PLAYGROUND CONDITIONS AND INJURY RISKS: IMPLICATION FOR ETHIOPIAN YOUTH SPORT ACADEMY

BIRUK AMARE SORATE

How to cite this article: Sorate, B.A., (September, 2015). Playground conditions and injury risks: Implication for Ethiopian youth sport academy. Journal of Physical Education Research, Volume 2, Issue III, 31-42.

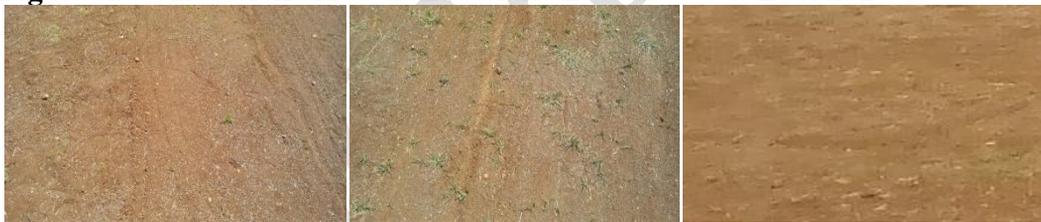
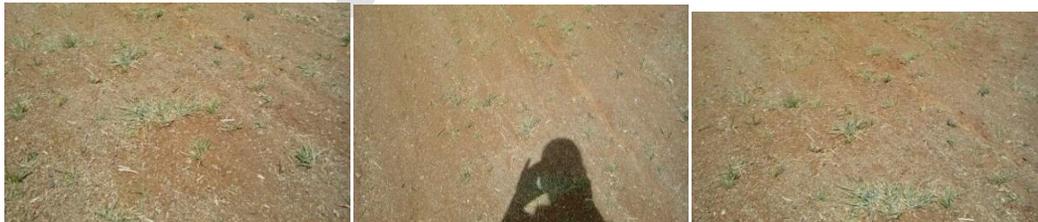
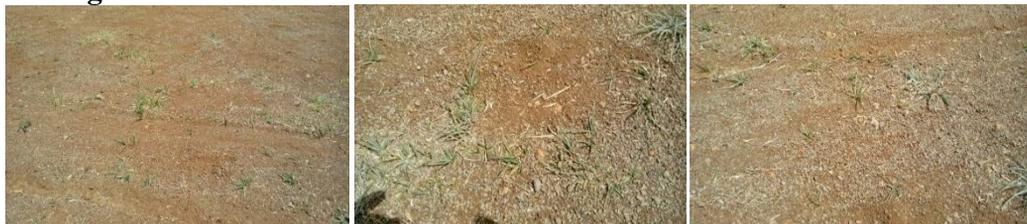
Figure 2. a. Location “A” b. Location “B” c. Location “C”

The below figures 2: a to i, indicates that the Ethiopian youth sport academy football pitch with normative data of the standard the grass cover dimension of the Best Practice Sports Ground Inspection process below the standards. The percentage of grass cover was estimated at < 25%.

The safety issues relate to bare patches being at a different level to the grassed surface causing an uneven surface and the different traction characteristics as players move from one area to another. Weeds, tussocks and tufts of different grasses can also lead to an undulating and uneven surface. Tripping and jarring injuries are the likely consequences (PQS, 1988).

This can show that the percentage of grass cover presents a hazard to players, and it can cause stability problems for players. Inspection process ideally, sports grounds should have a 100% grass cover. It should be noted that as the percentage of bare area increases, the associated injury risk potentially increases as well.

Considering the major findings and conclusions of the study, it is important to provide the following recommendations. The quality of pitch maintenance during and after the playing season is the most critical factor in providing a playing surface that is fit. Grounds men should know which management tools adversely affect the quality of the pitch. A yearly assessment of surface is required and the results must be within certain limits and the concerned body should aware that playgrounds must cover with grasses that minimize the risk of injuries for the trainees.

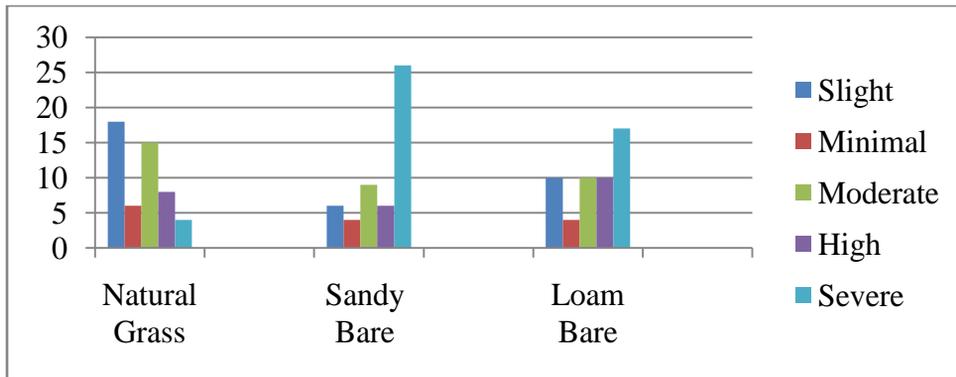
Figure 3: Incidences of injury in different types of field in frequency

Incidences of injury players on natural grass, sandy bare field and loam bare field are presented in Table 6 and fig 3 as function of injury severity. On the natural grass field the respondents were respond 35.3% slightly, 11.8% minimal, 29.4% moderate, 15.7% highly and 7.8% severely injured, and in sandy bare field the

respondents were respond that 11.8% slightly, 7.8% minimal, 17.6% moderately, 11.8% highly and 51% of severely injured and also in loam bare field the respondents were respond that 19.6% slightly, 7.8% minimal, 19.6% moderately, 19.6% highly and 33.3% severely injured. This analysis showed the overall incidence of injury between the surfaces during training or match play for the players are severe in sandy and loam bare fields.
